ENGINEER FAULT REPORT

Results from test JOB13071

47 Richmond Road
Hackney
London

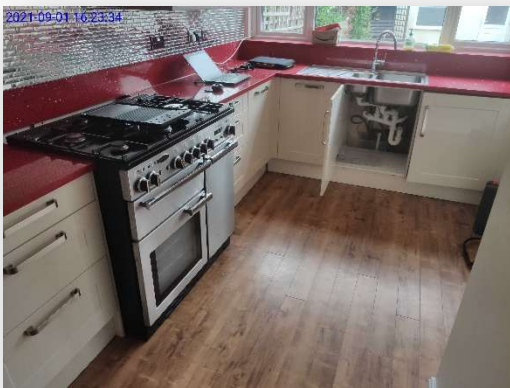
Water supply

C2 FAULT

Water : Main equipotential earth bonding cable has been disconnected from the water supply pipework(A15).

There should be a green and yellow earth cable connected to the water supply pipe that runs back to the fuse board which is not connected.

Reconnect the existing earth bonding cable to the water supply pipe.

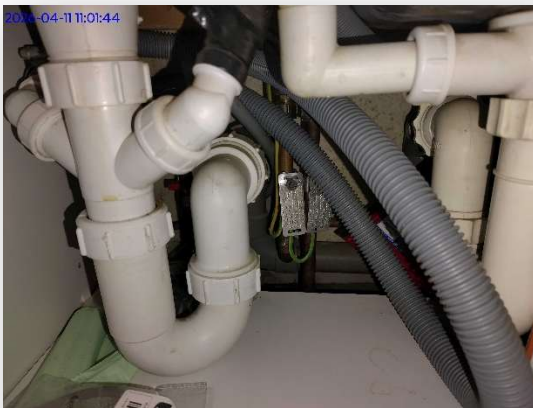
Fixed Onsite

Rectified on site - no earth bond cable connected to the water supply pipework
(Water connection - Visual Inspection)

Reconnected the earth bonding cable to water pipe and confirmed is connected
